**BATTERY ANOMALY INVESTIGATION
SATELLITES 9437 AND 9438**

TRW DEFENSE AND SPACE SYSTEMS GROUP
ONE SPACE PARK
REDONDO BEACH, CALIFORNIA 90278
REPORT NO. 32824-AR-019-01

APRIL 1980

FINAL REPORT

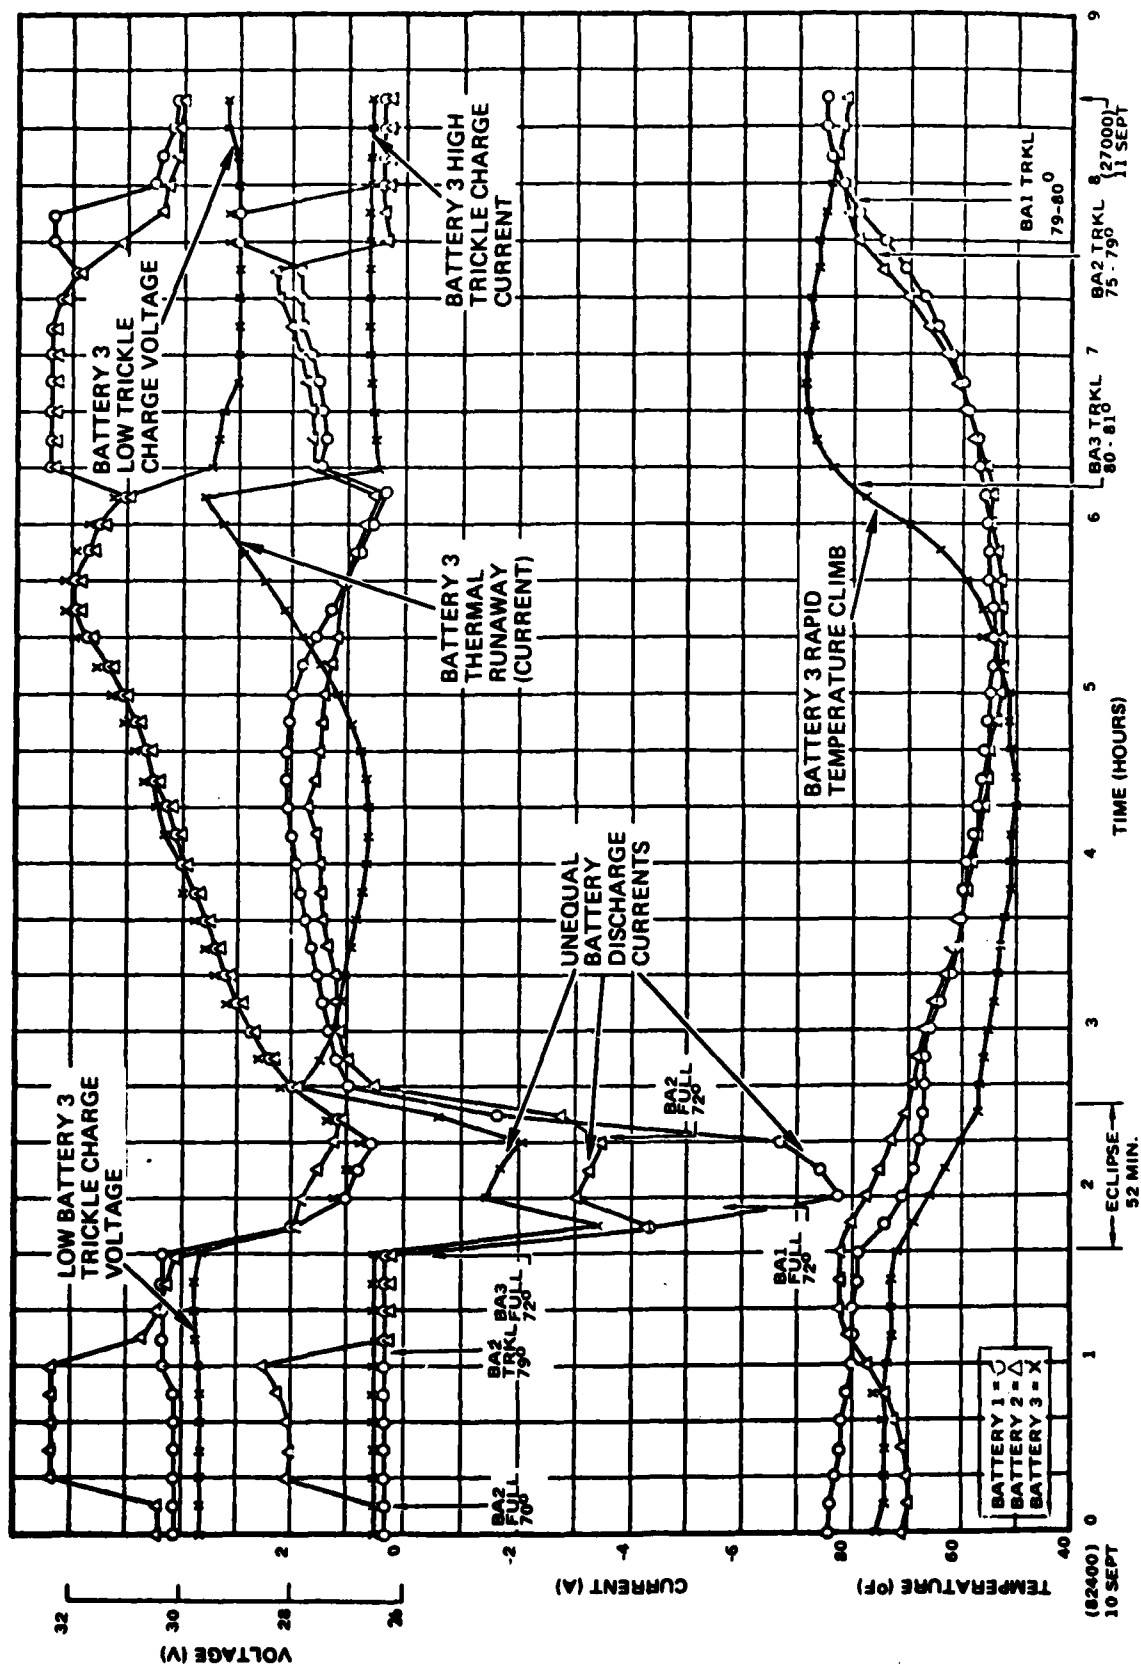
Figure 3-1. Satellite 9437, 10 to 11 September 1978, 27-Hour Automonitor Showing Battery 3 Anomalous Behavior

- a) Although the three batteries were under automatic control, (auto mode) a severe current imbalance occurred during discharge. Battery 3 failed to carry its share of the discharge load current, and accepted more than its share of charging current.

- d) The solid state temperature switch (SSTS), which is designed to operate at 77°F, appeared to be operating at an indicated temperature of 80 to 81° on Battery 3, and 79 to 80°F on Battery 1. This was found to be due to temperature gradients in the battery rather than a SSTS malfunction.

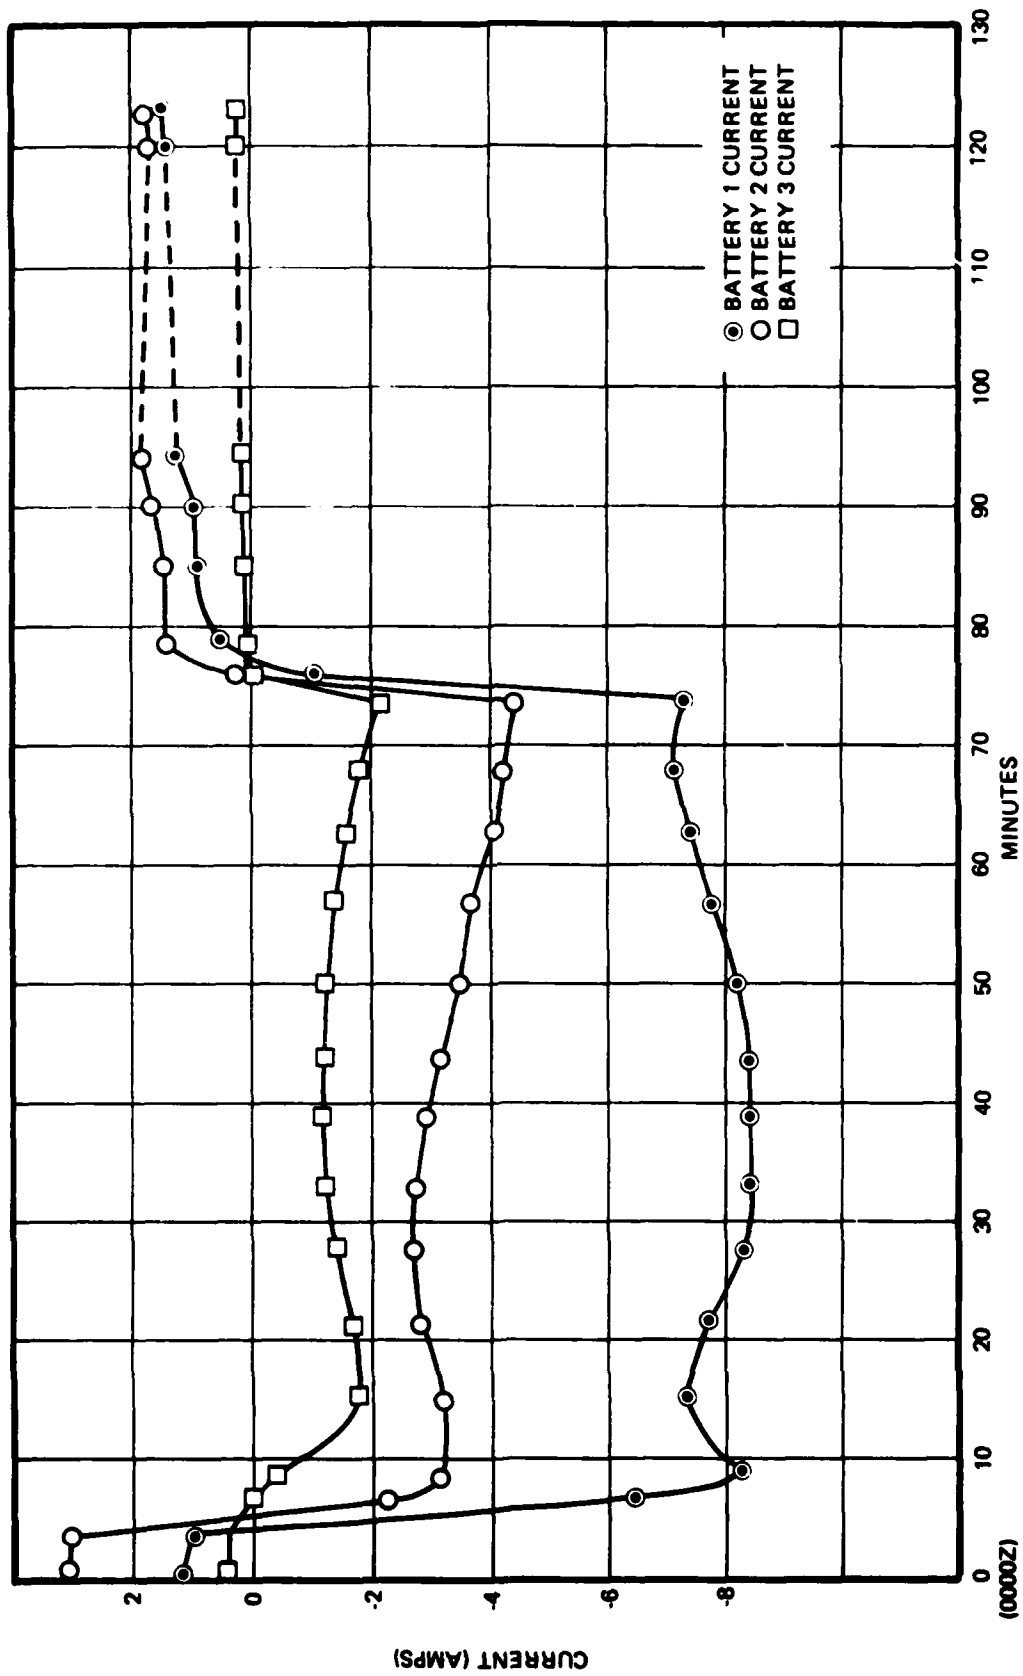
Severe imbalances in battery discharge currents continued, as shown in Figure 3-2. (Telemetry data falling outside the current sensor design range has been corrected.)

Figure 3-2. Satellite 9437 - 26 September 1978 - Eclipse 24 - Battery Load Sharing

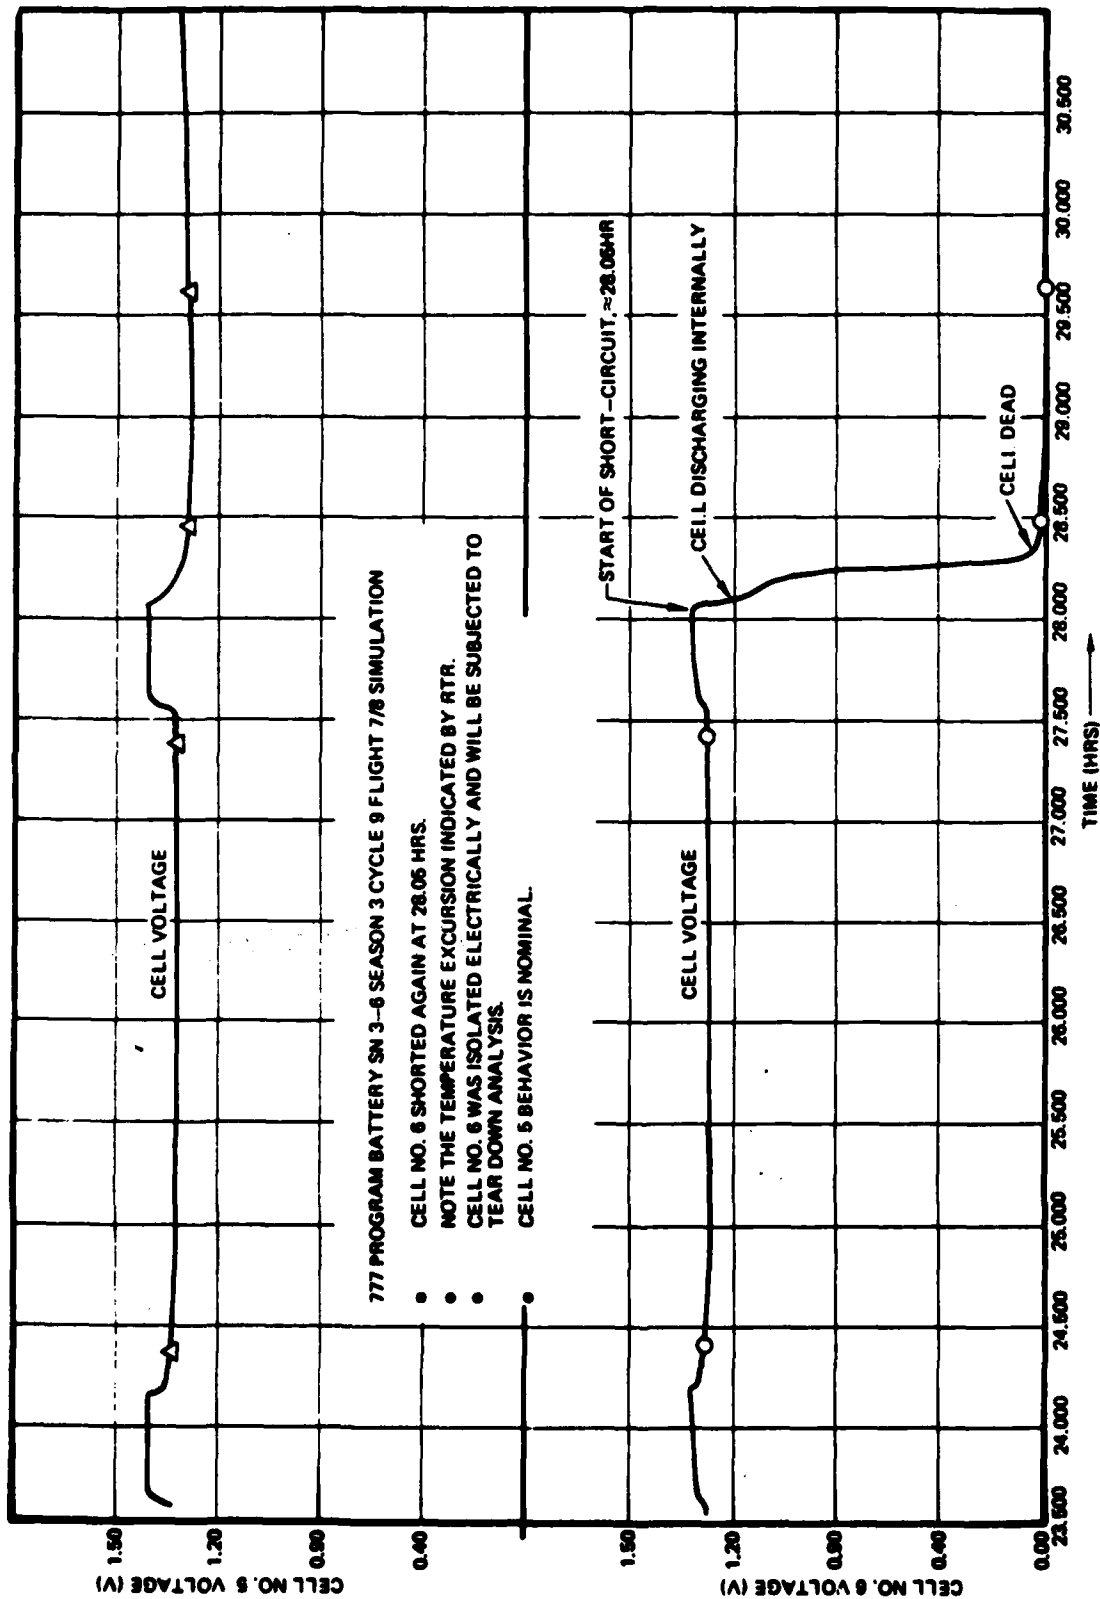
A laboratory test was conducted in which one flight-configuration battery was subjected to a simulation of cycling conditions observed on Satellites 9437 and 9438 and another to the anticipated conditions of Satellites 9441 and 9442. The 9437/9438 simulation used a bus voltage limit of 32.4 V. The 9441/9442 simulation used a lower voltage limit of 31.8 V. During this test, Battery S/N 3-6, which was tested under Satellite 9437/9438 conditions, developed a permanently short-circuited cell during Cycle 9 of Season 3 (in-flight failures occurred between Cycles 1 and 20 of Season 3 in Satellites 9437 and 9438). It was also observed that permanent cell short-circuits were preceded by a period of anomalous operation and, upon occasion, by self-clearing short circuits. The onset of a short-circuit is clearly seen as an abrupt drop in cell voltage to zero volts, and is confirmed (in centrally located cells) by a rapid rise in temperature of the RT2 thermistor which is centrally located on one of the two cell blocks (see Figure 2-1). This rapid temperature rise results from internal heat dissipation due to self-discharge of the shorted cell through the internal short-circuit (as shown in Figures 4-1 and 4-2).

Figure 4-2. Battery S/N 3-6 - Season 3, Cycle 9 - Short Circuit Event - Cell Data

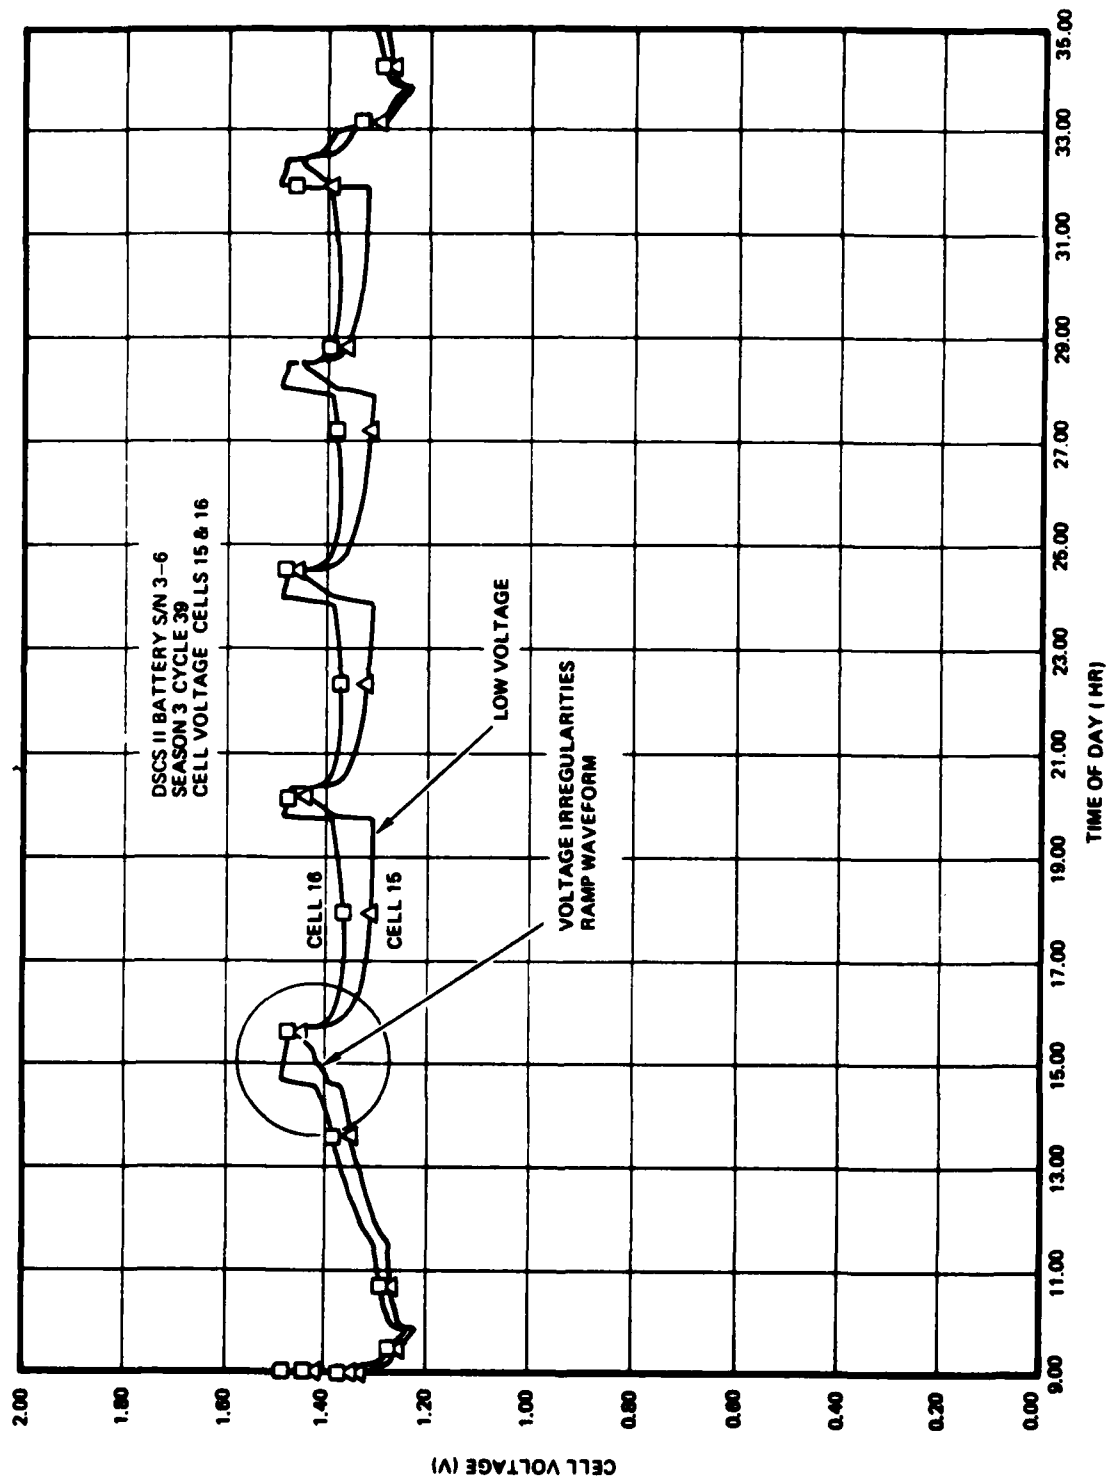
Two additional cell anomalies were observed during Battery S/N 3-6, Season 5 operation. However, in both instances the cells exhibited preshort signatures during Season 3. The presence of the signature prior to the change in charge mode is interpreted as evidence that the damage had occurred before the switch to the more benign trickle charge mode. There are no indications of anomalies initiated subsequent to the switch to trickle charge.

Figure 4-4. Battery S/N 3-6 - Preshort Signature - Cells 15 and 16

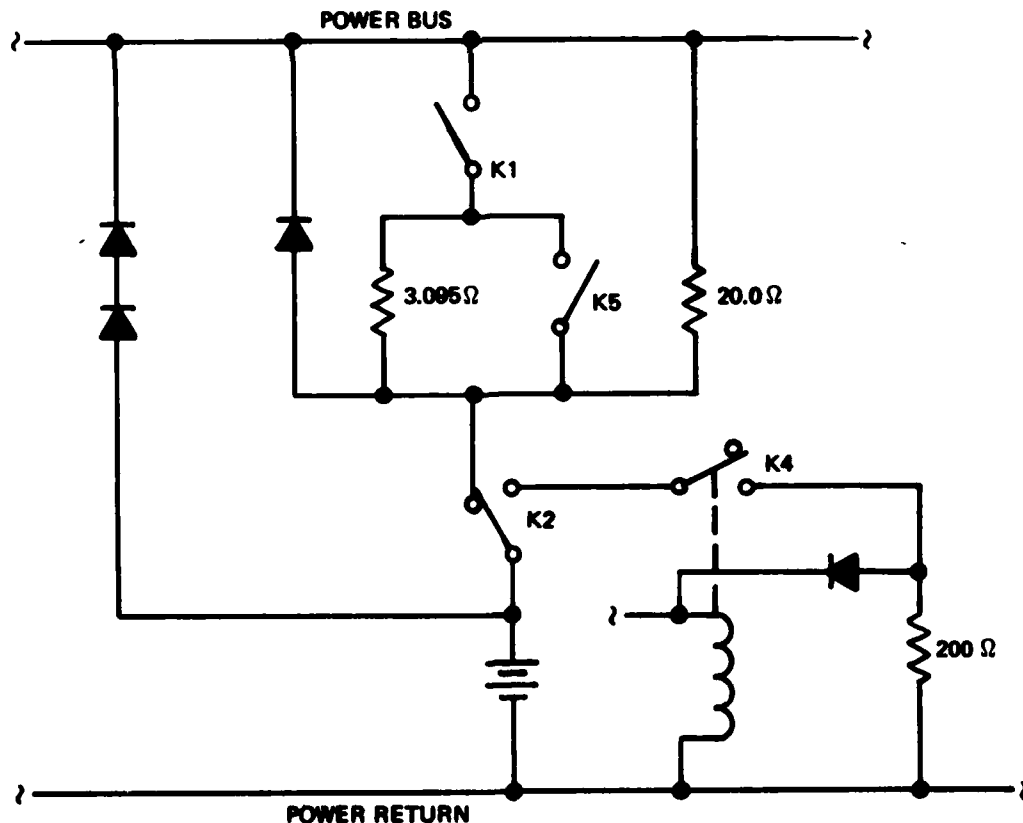
The resistance values and voltages were selected as a result of a detailed boundary conditions analysis, in which the effects of bus voltage, current, resistance, battery voltage and temperature were studied parametrically to determine a set of safe operating regions for batteries with 22 normal cells, and with 21 operational cells and one shorted cell. This report will be found in Appendix 8.

Figure 5-1. Revised Charge Control Circuit

The direct connection relay (K5) has been included in the change to provide additional flexibility in meeting unusual conditions which could occur during a satellite mission. The additional capability and flexibility provided by the K5 relay are as follows:

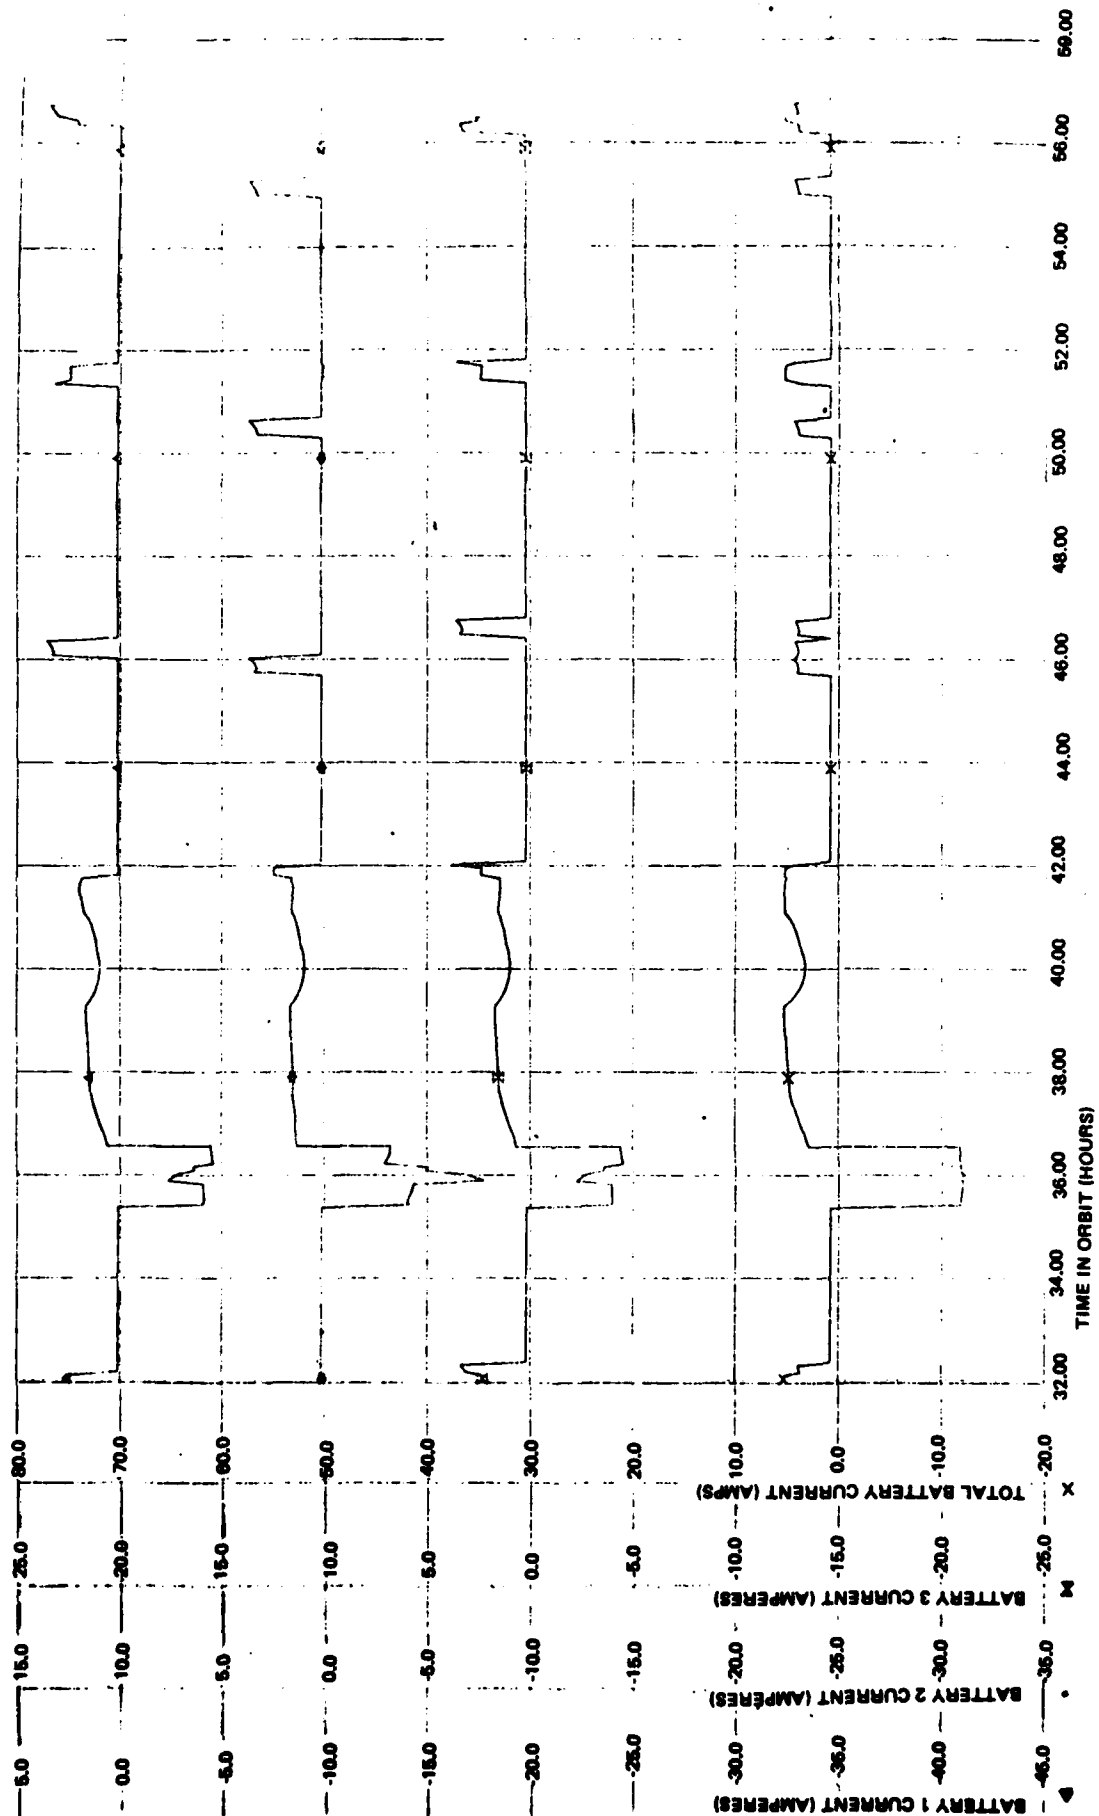
Figure A1-6. Battery Charge Control Interactions

pulse-charging signature, after which the three batteries enter into eclipse with the K1 relay open, drawing approximately equal discharge currents. Just prior to 36 hours, the Channel 2 K1 relay closes, eliminating the diode from the Battery 2 discharge path. Battery 2 discharge current increases (in the negative direction), and since the load requirements are constant, the discharge currents of Batteries 2 and 3 decrease accordingly. Because Battery 2 is being depleted more rapidly than the others, its current output falls from the initial surge, accompanied by a rise in the output of Batteries 1 and 3. After a few minutes, Batteries 1 and 3 K1 relays close simultaneously (within the resolution of the computer model) causing a decrease in Battery 2 current, and a sharp rise in Battery 2 and 3 currents. The eclipse ends shortly thereafter.

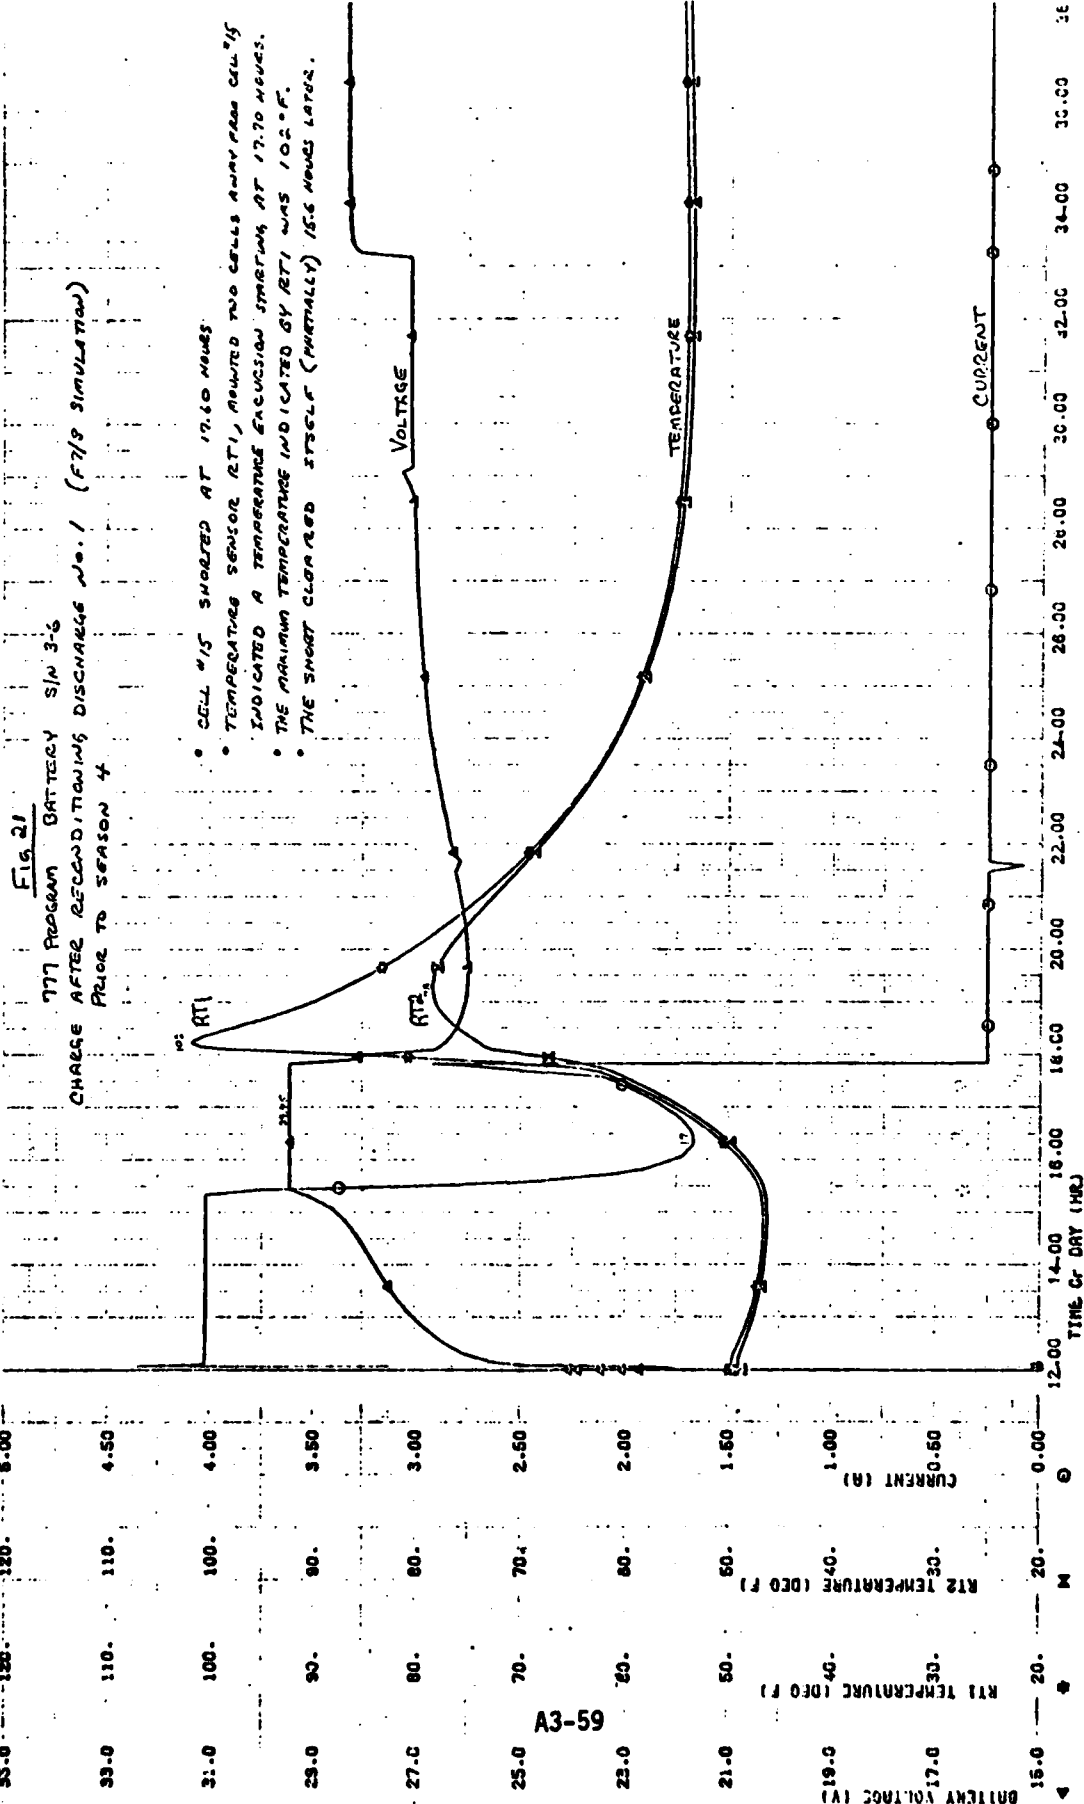
- CELL #15 SHORTED AT 17.60 HOURS
- TEMPERATURE SENSOR RT1, MONITORED TWO CELLS AWAY FROM CELL #15
- INDICATED A TEMPERATURE EXCURSION STARTING AT 17.70 HOURS.
- THE MINIMUM TEMPERATURE INDICATED BY RT1 WAS 102°F.
- THE SHORT CLEARED ITSELF (PARTIALLY) 15.6 HOURS LATER.

DRY 118 HOUR 0000 TEST 7736 - CHARGE AFTER RECONDITIONING DISCHARGE NO. 1

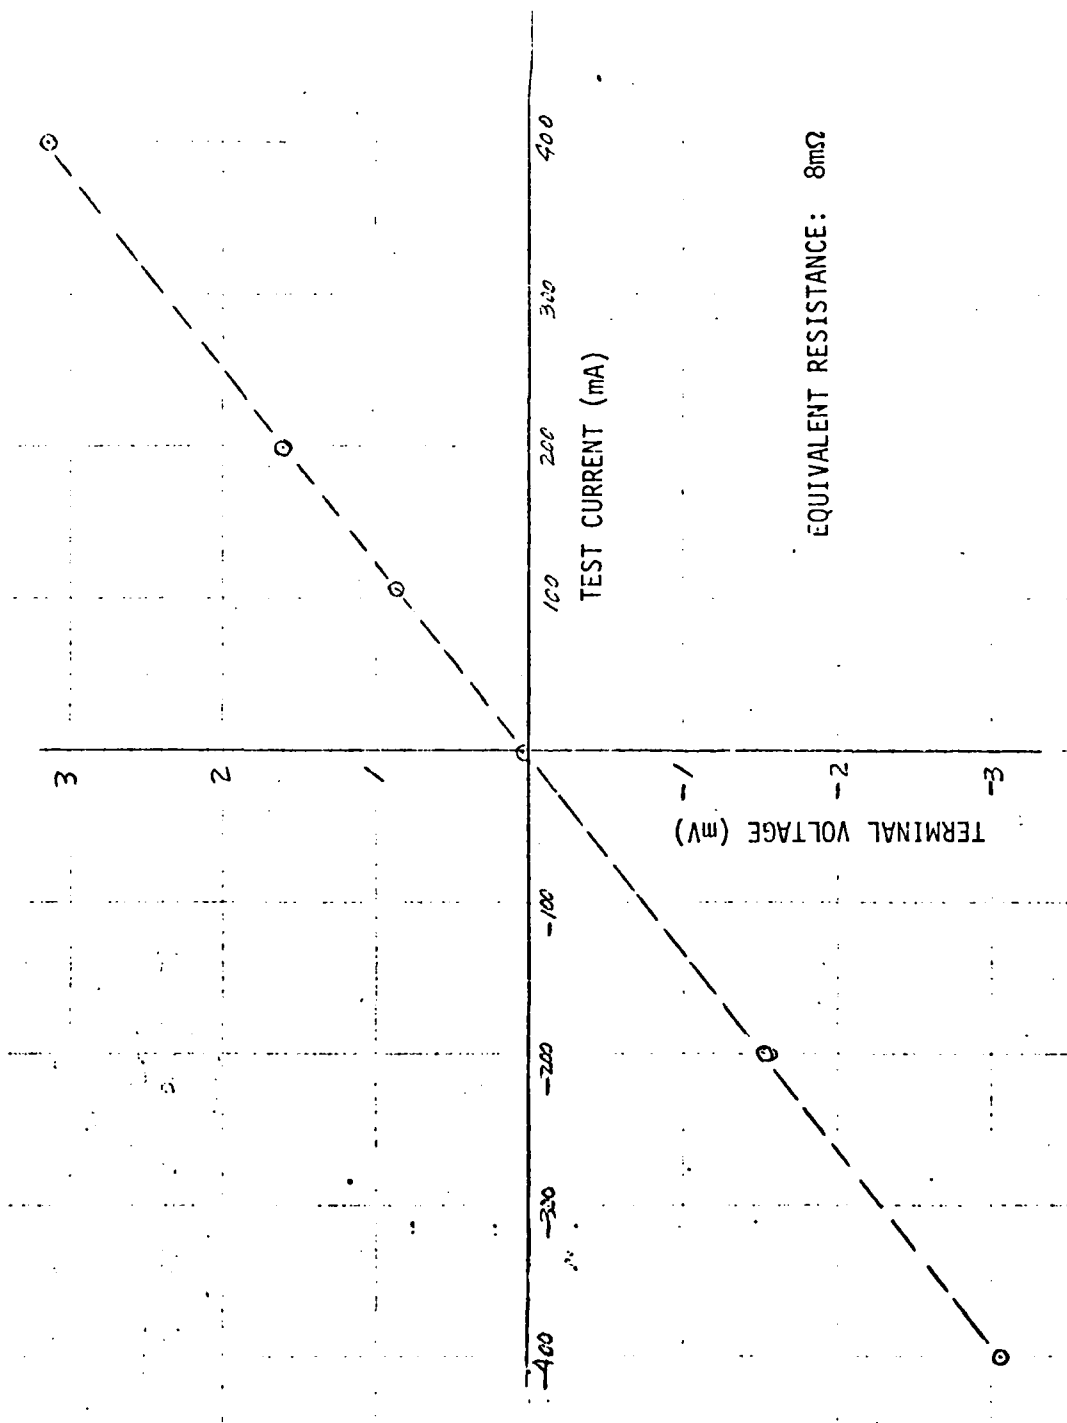
Figure 1. Current voltage plot for cell resistance of shorted cell, 8E005, S/N 171-L01.

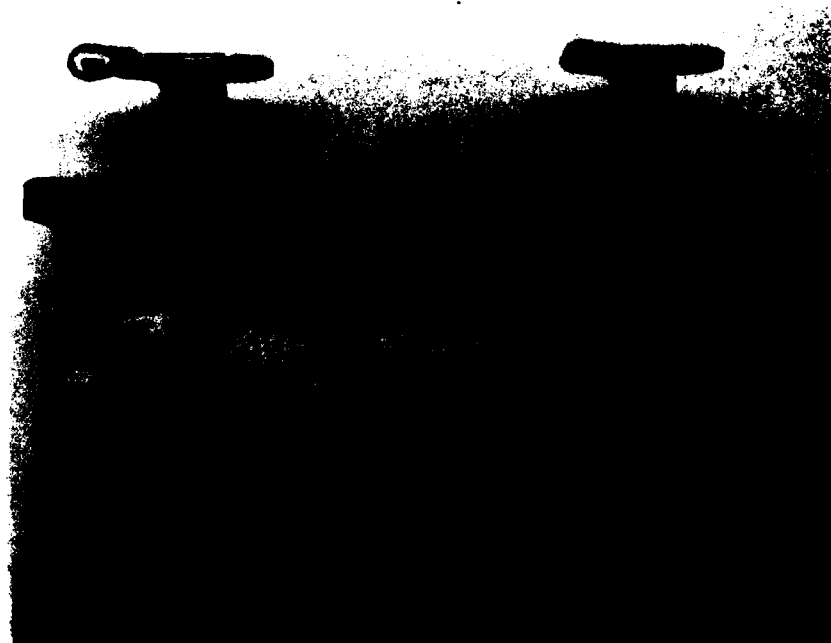
Figure 3. Rear view of cell with plates partially withdrawn
(TRW 153391-79)

To facilitate inspection of the tab area and cutting of tabs, the plate pack (and cover) was pushed upward with respect to the remainder of the case by about one inch. Photographs of the open portion of the cell from the four sides are shown in Figures 2 through 5. Note that the separator material is not visible around two of the centermost positive plates on the positive plate tab end (Figure 4) and around four of the centermost positive plates on the negative plate tab end (Figure 5).

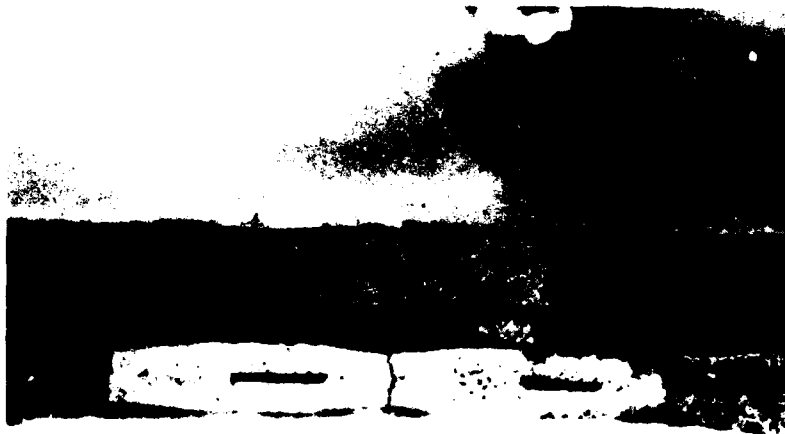
= Figure 26. View of Section V, 12x

As grinding continued beyond the center of the "burned" spot, a relatively large particle was encountered which appeared to bridge the gap between the plates (designated Section V). Figures 26 and 27 show two views of this section taken with an ordinary camera, while Figures 28 and 29 were taken with the metallograph (images transposed left to right relative to Figures 26 and 27). The particle does not appear to be as large, compared to the space between the plates, as it does in Figures 26 and 27. This is because only the material in the plane of the section shows in the metallograph, whereas in Figures 26 and 27 one is able to see through the polished surface of the resin and hence to see the bulk of the particle located behind the section plane. Note in Figure 28 the missing piece of the negative plate sinter (center photo).

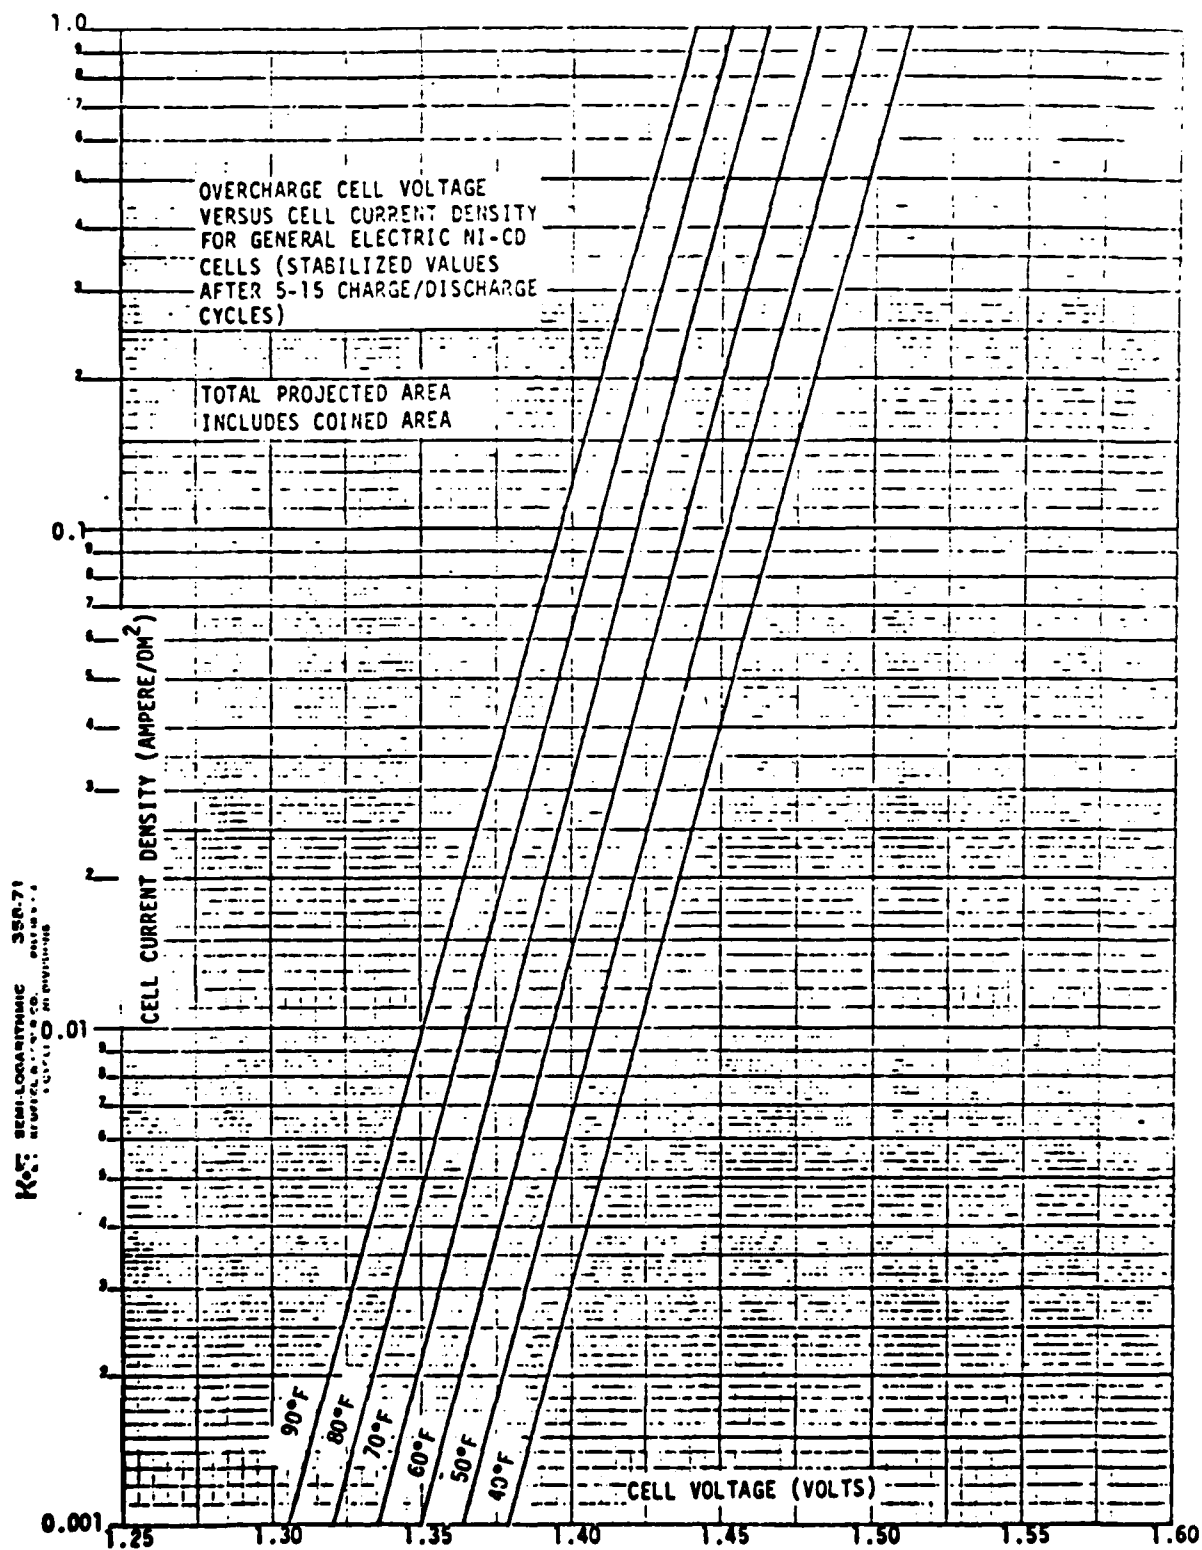
FIGURE 4-1. OVERCHARGE CHARACTERISTICS FOR GENERAL ELECTRIC NICKEL-CADMIUM CELL

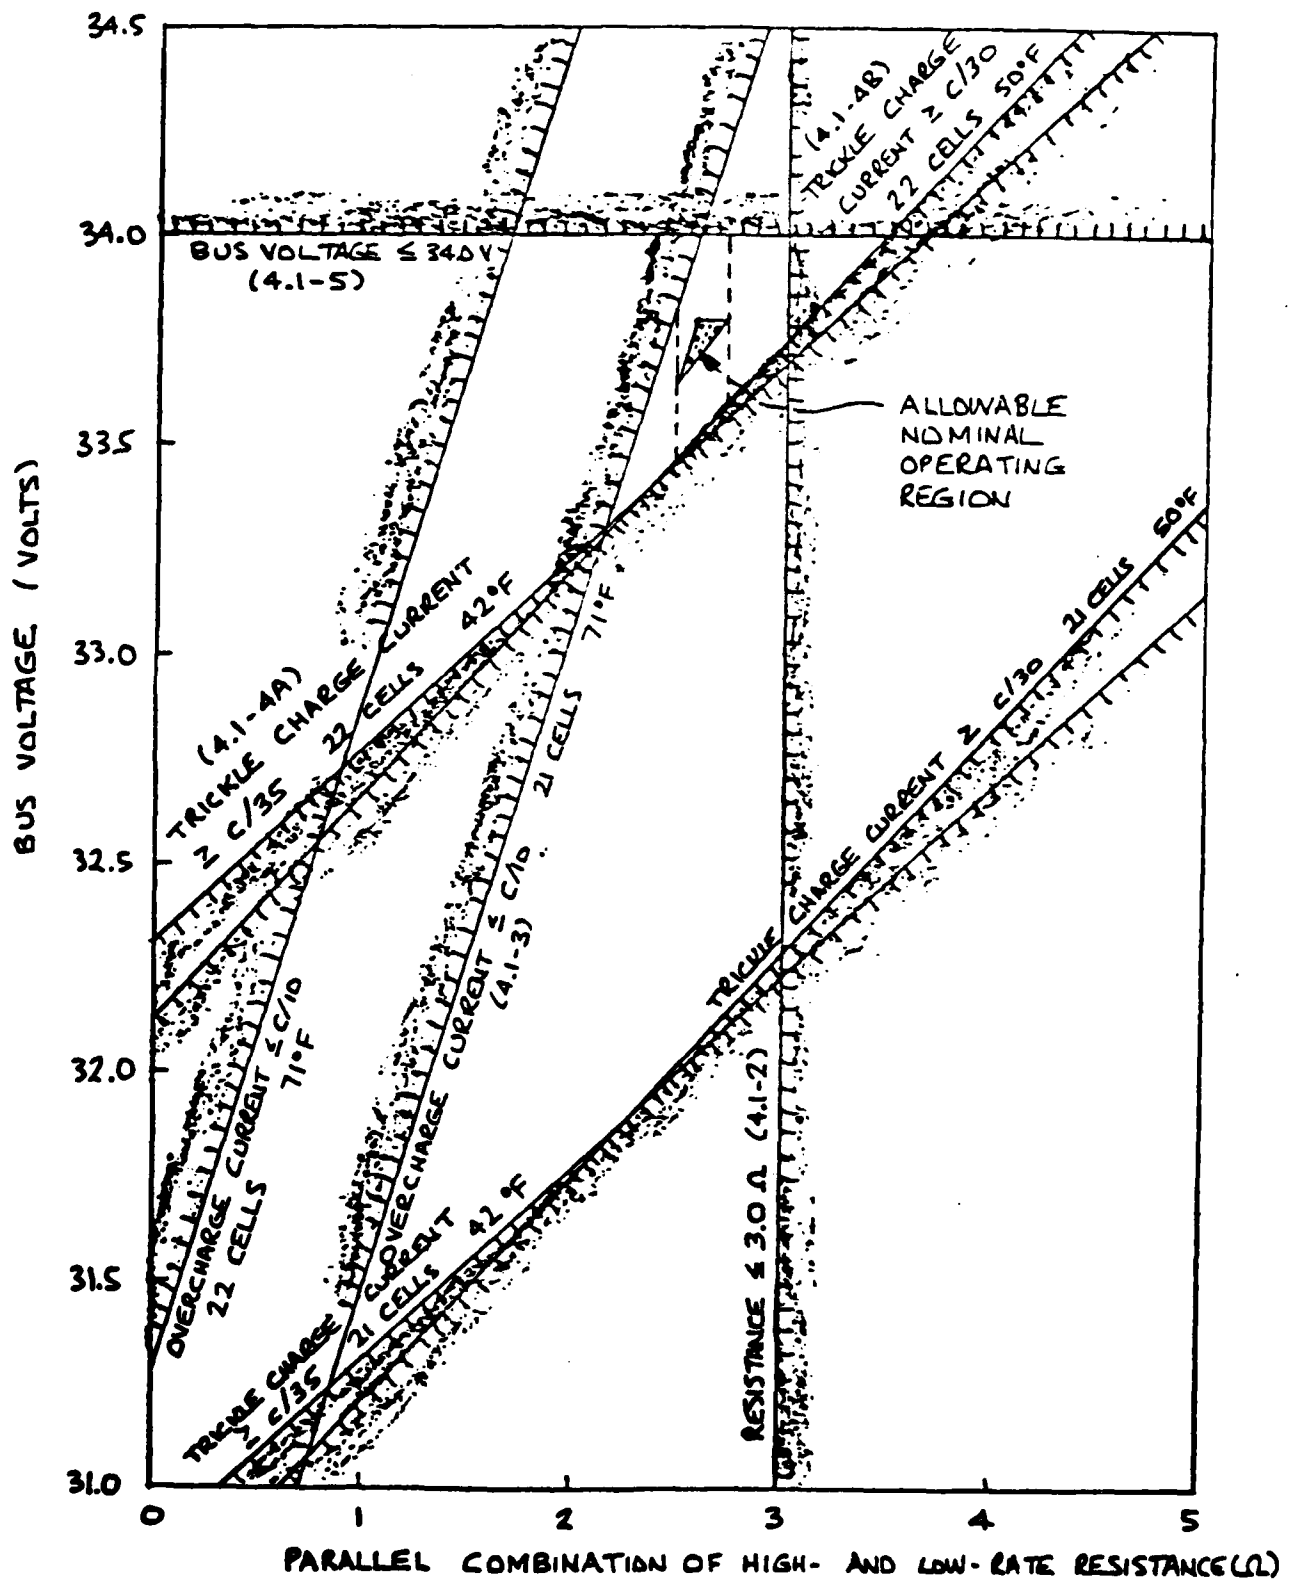
The determination of actual high-rate limiting resistance R_{HR} is deferred until selection of low-rate limiting resistance R_{LR} .

FIGURE 4-2. HIGH-RATE RECHARGE MODE CONSTRAINTS

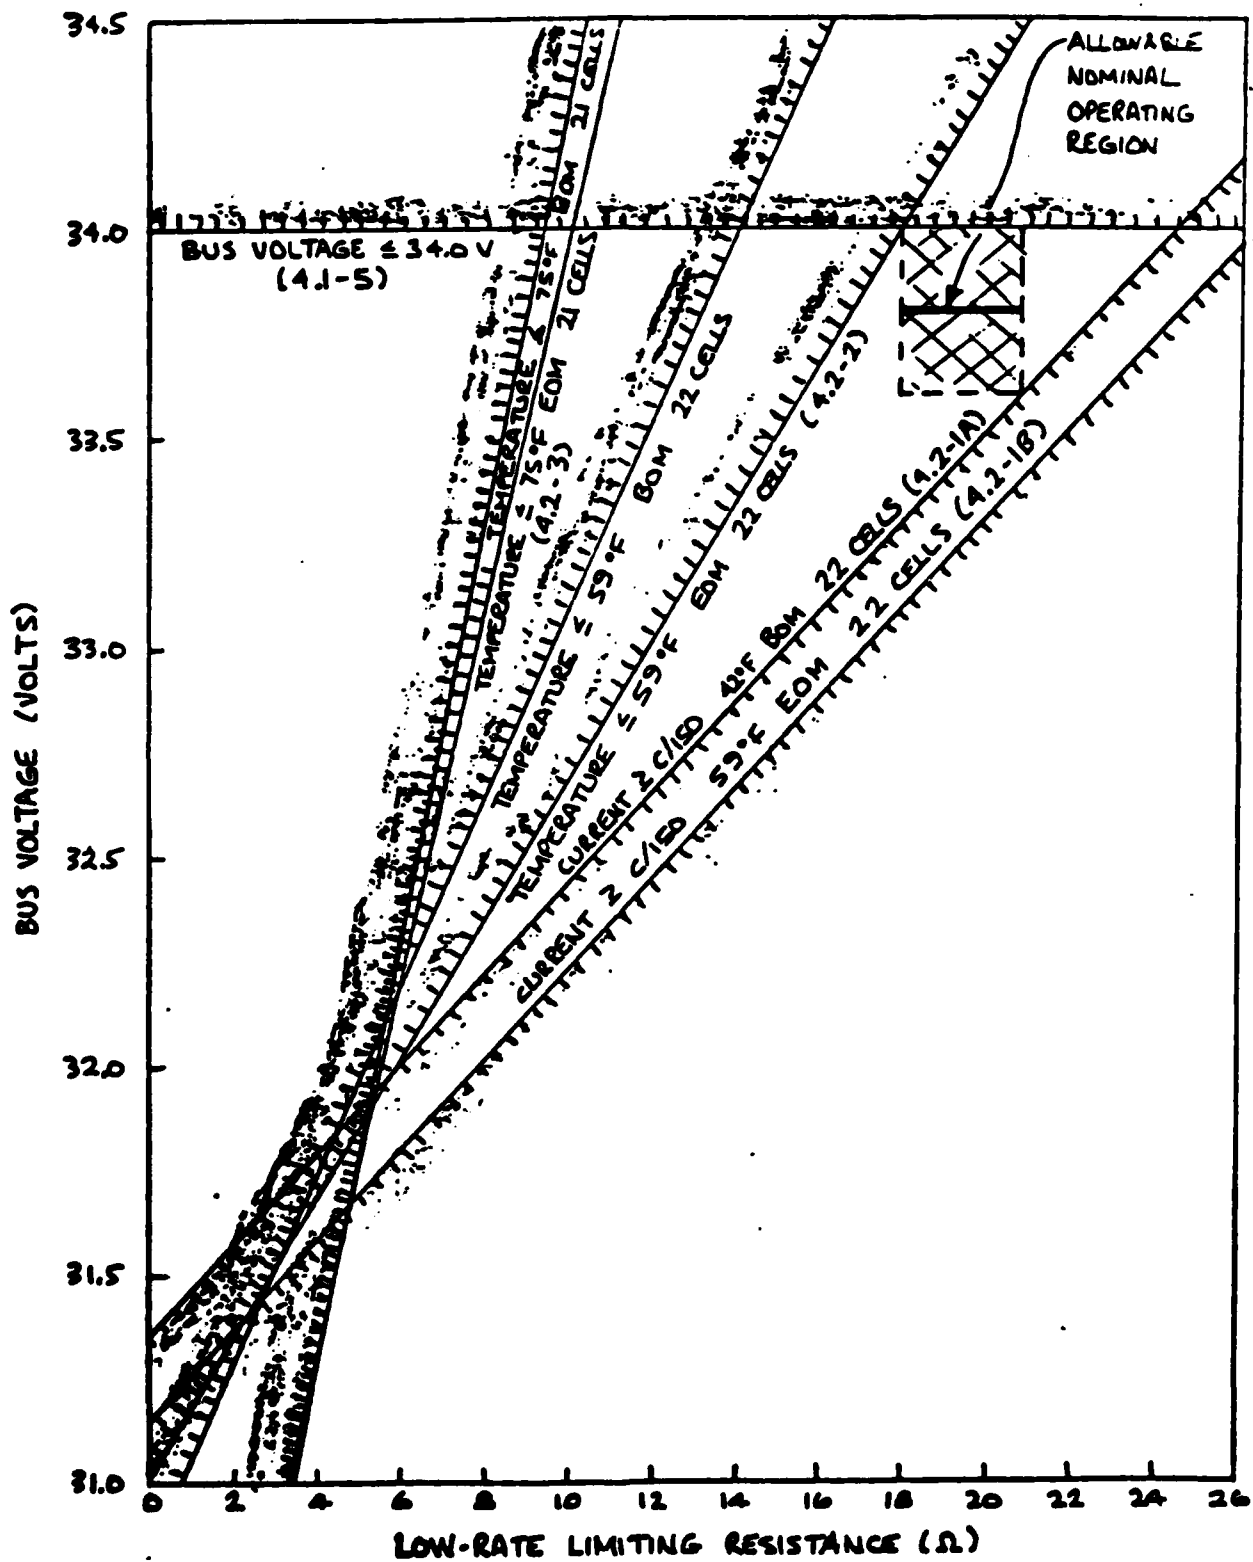
$$2.554 \leq R_{PL} \leq 2.726 \quad (4.3-1)$$

FIGURE 4-4. LOW-RATE TRICKLE MODE CONSTRAINTS
